PROJECT PORTFOLIO - LABU BUTU WASH

NARRATIVE REPORT	
A. General Information	
Reporting Period	From: 2/06/2025 To: 23/09/2025
B. Current Period Activity Status	
<i>Provide a list of Current Reporting Period Activities and the status of each. Activities should have clear links to the Project Schedule.</i>

LABU BUTU WATER SYSTEM LAYOUT PLAN

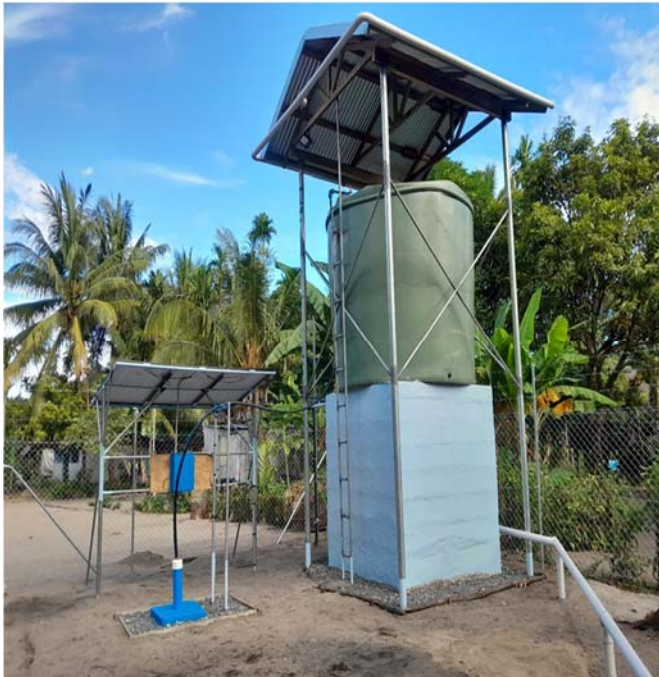
Completed sustainable smart water system

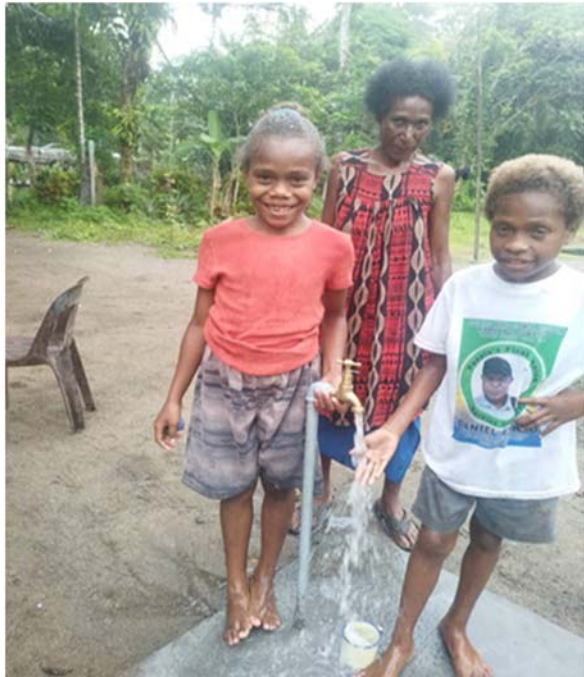
Water point tap 1

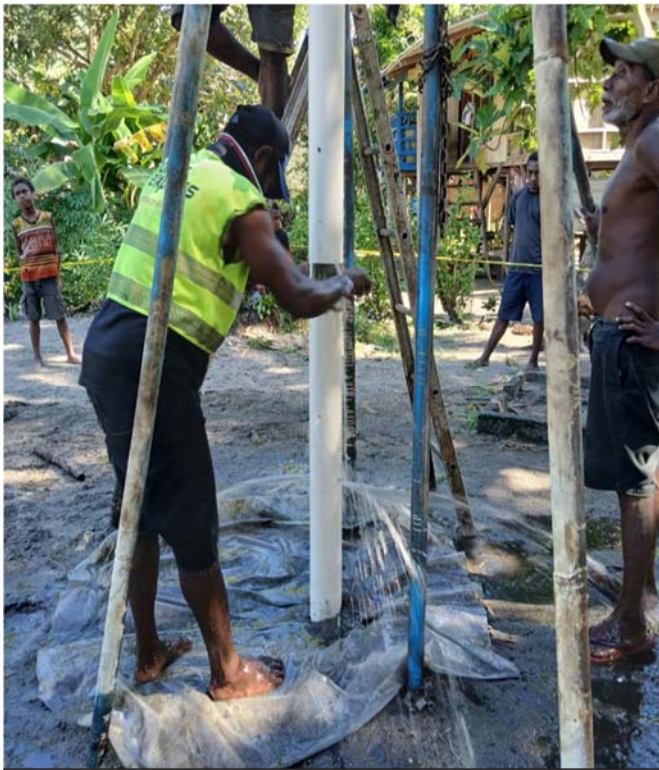
Inserting borehole pressure pipe casing

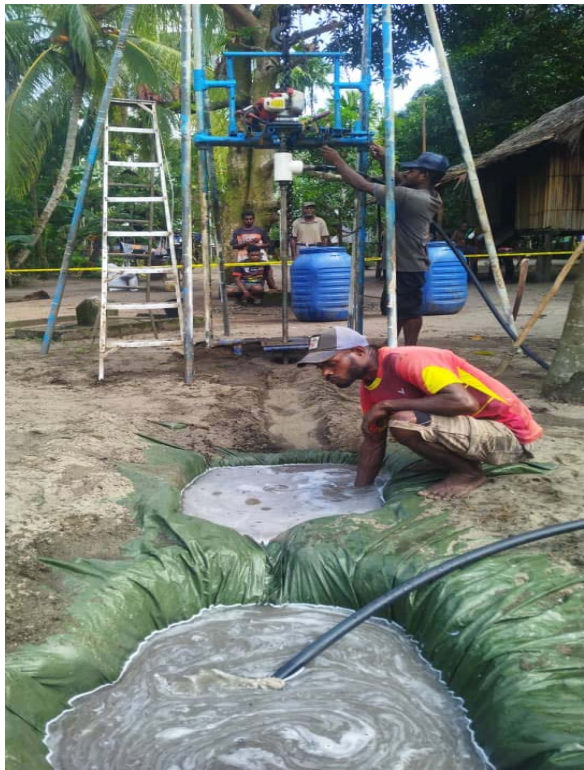
Water drilling mud setup

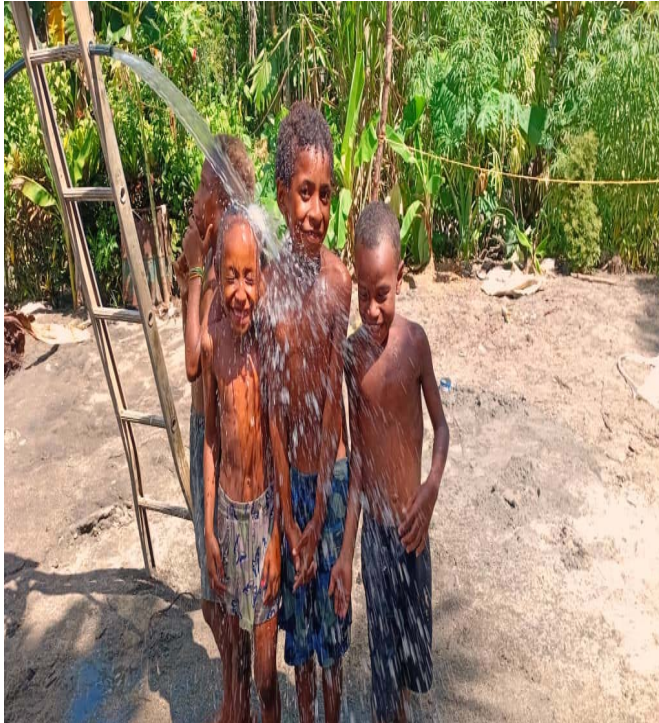
First flow of water from the borehole

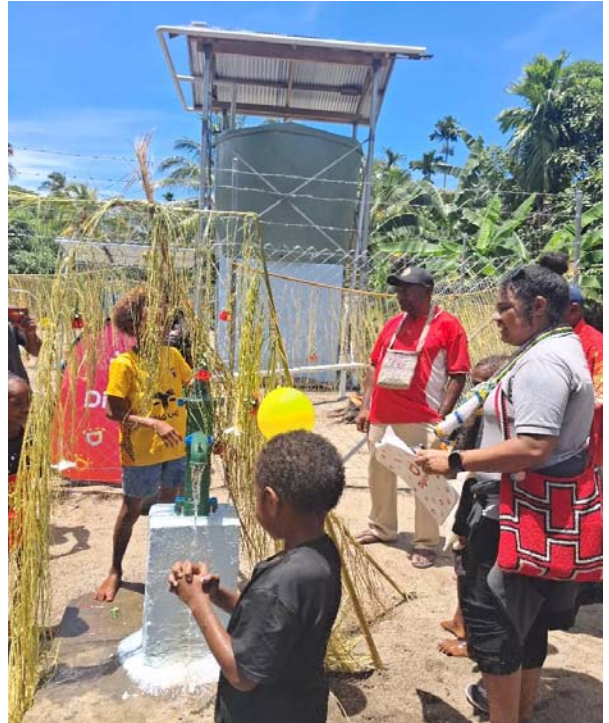
The Launching – Manual pump setup

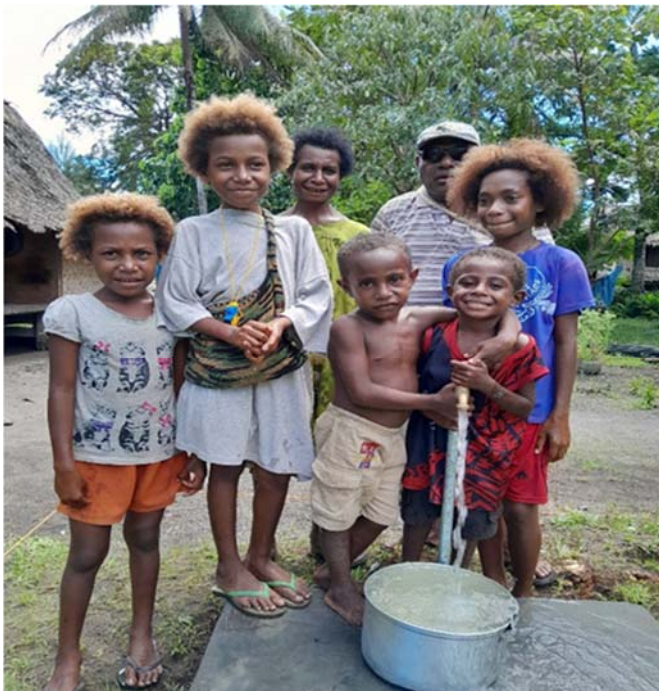
Water point tap 2

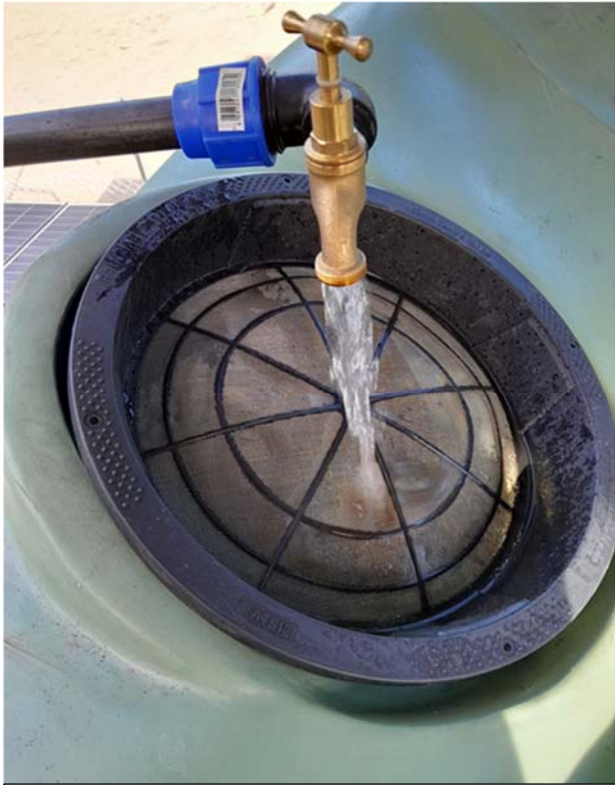
Water pumped by solar into storage tank

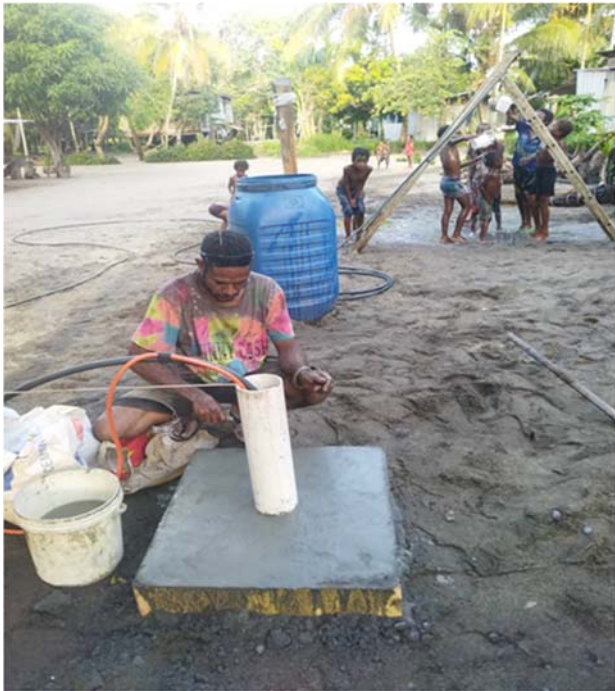
Borehole sealing and monitoring

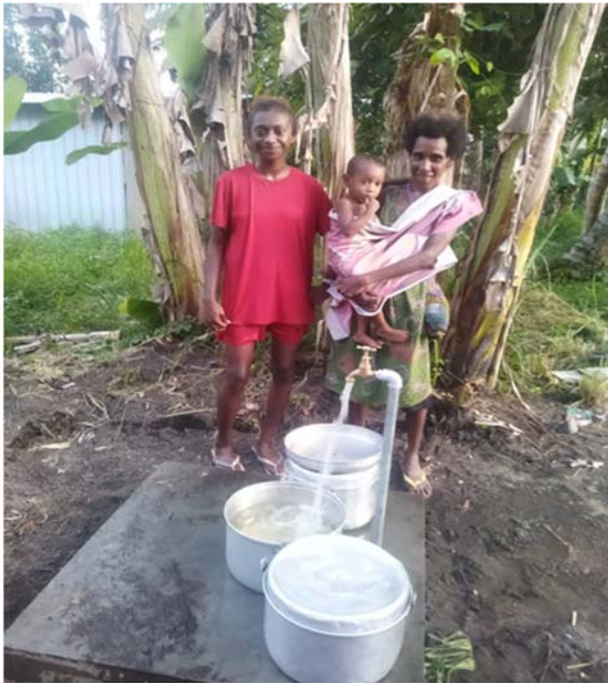
Water point tap 3

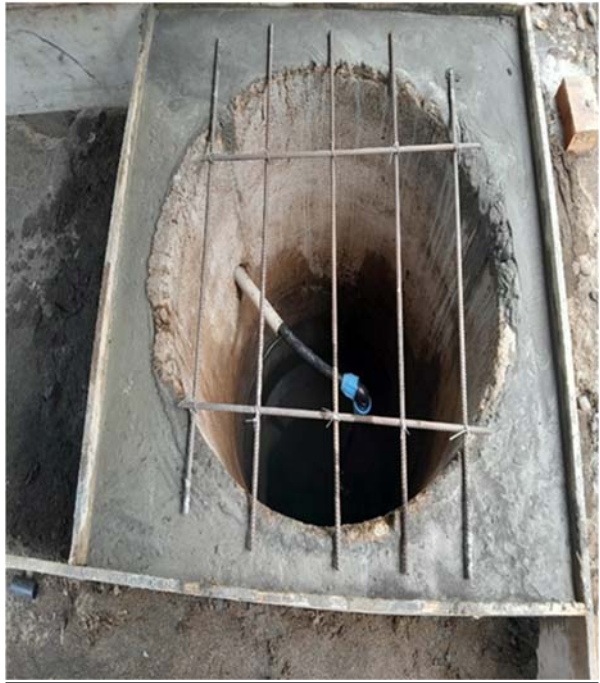
Well built in 1964 - rejuvenated – reservoir

<p>Rehabilitation of Old Well: An abandoned community well, unused for over 30 years, was restored and now serves a dual purpose: as an underground reservoir supporting the solar borewell system and as a manual water source via hand pump.</p>
<p>Enhanced Storage & Harvesting: A 9,000L tuffa tank was fitted with a protective shelter and rainwater harvesting system. Overflow water is redirected to the rejuvenated reservoir, ensuring no water is wasted.</p>
<p>Improved Safety & Access: Solar lighting was installed at three tap locations and the central water facility, allowing safe access to water points during night hours.</p>
<p>Water Quality & Treatment: A sediment filter was installed to improve water quality, and samples of both raw and filtered water were sent for laboratory testing at the PNG University of Technology.</p>
<p>Infrastructure Protection: A perimeter fence and gate were built to secure the borewell, solar panels, reservoir, and storage tank.</p>
